Name Of Dam: KEOKEE DAM  
Location: LEE COUNTY, VIRGINIA  
Inventory Number: VA 10502

# PHASE I INSPECTION REPORT NATIONAL DAM SAFETY PROGRAM

**BY**  
**GILBERT ASSOCIATES, INC.**

AUGUST, 1978

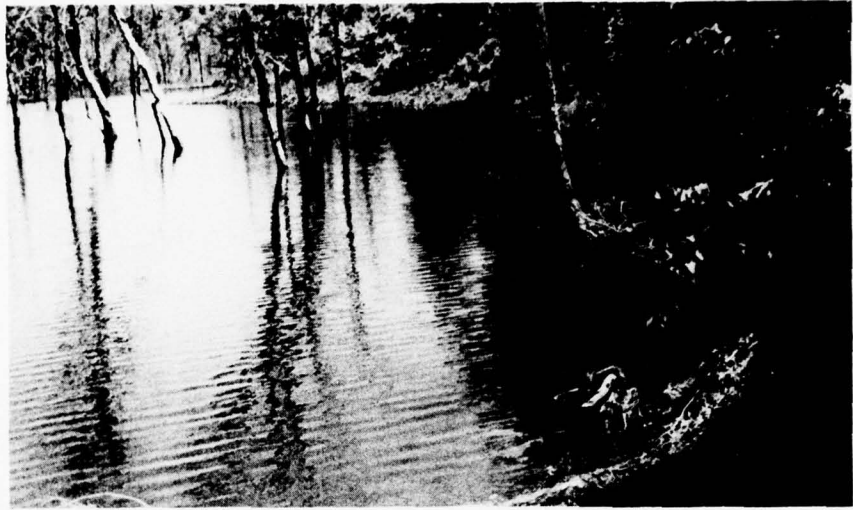
RESERVOIR SHORELINE AT LEFT:  
NOTE DEAD TREES IN WATER

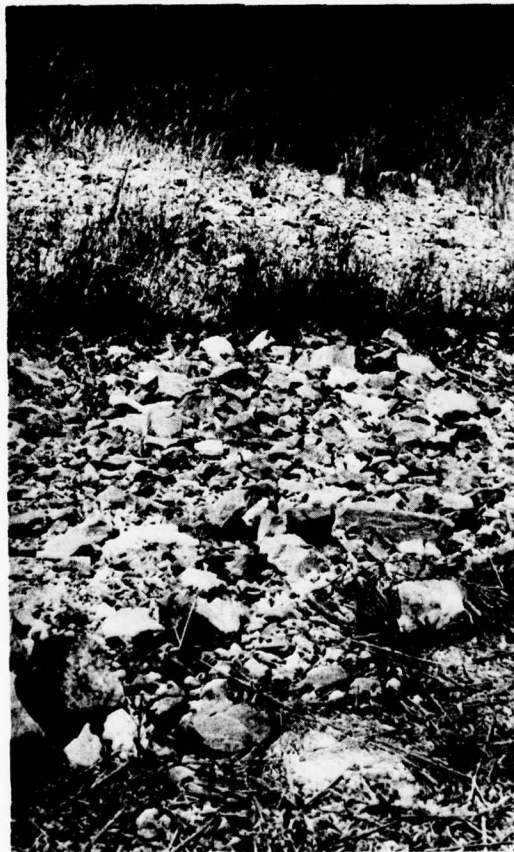
RIPRAP ON UPSTREAM SLOPE  
OF DAM

d. If bank erosion is noted due to the low water level over an extended period of time, riprap should be considered for the shoreline at the dam.

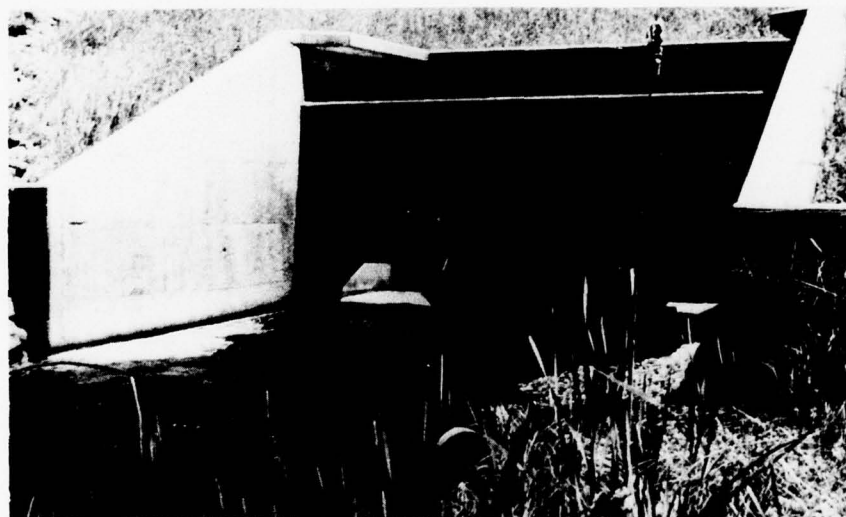
IMPACT STILLING BASIN AND SEINE BOX

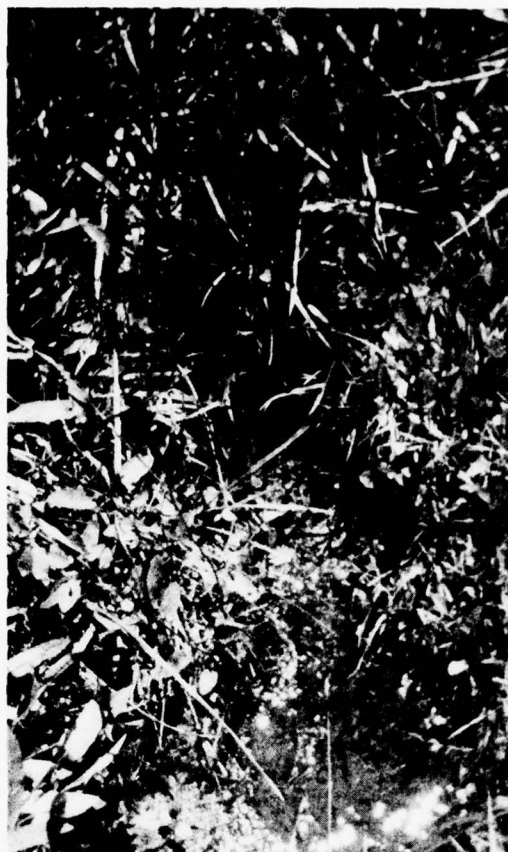
c. There is an area of leakage at the left abutment which has not been repaired, although the owner has lowered the reservoir, temporarily stopping the leak. He has a plan for sealing a portion of the reservoir with bentonitic clay where he believes the leak to be originating based on a dye test (See Appendix VI-B). The leakage could be detrimental to the safety of the dam if allowed to continue. An eroded area caused by this seepage exists on the downstream valley wall.

CLOSE-UP OF THE LEAK AREA AT  
LEFT ABUTMENT

c. The owner should successfully complete his attempt at sealing the reservoir to stop or reduce the downstream left abutment seepage soon. In any event, the leakage should be permanently stopped prior to raising the reservoir level.

f. Also, the leakage potential of the rock strata at shallow depths needs further verification. Very soon after repairs are made on the leakage area, the eroded downstream area should be repaired.

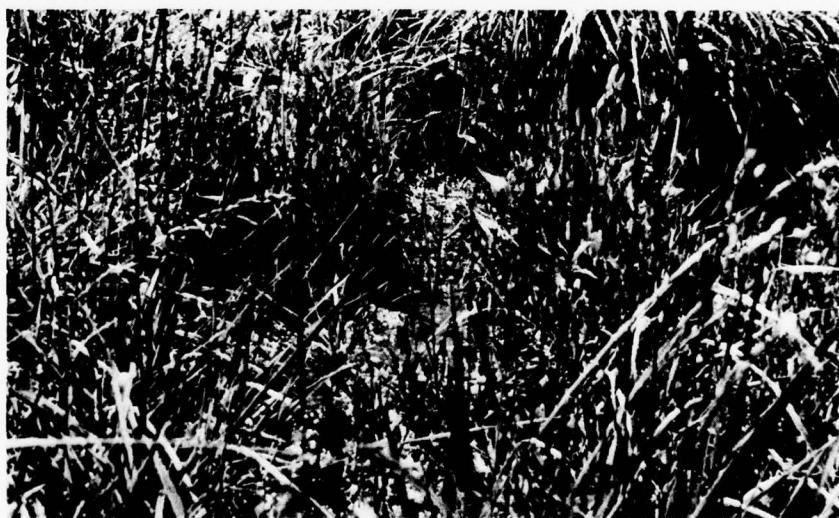
LEAK AREA AT LEFT ABUTMENT

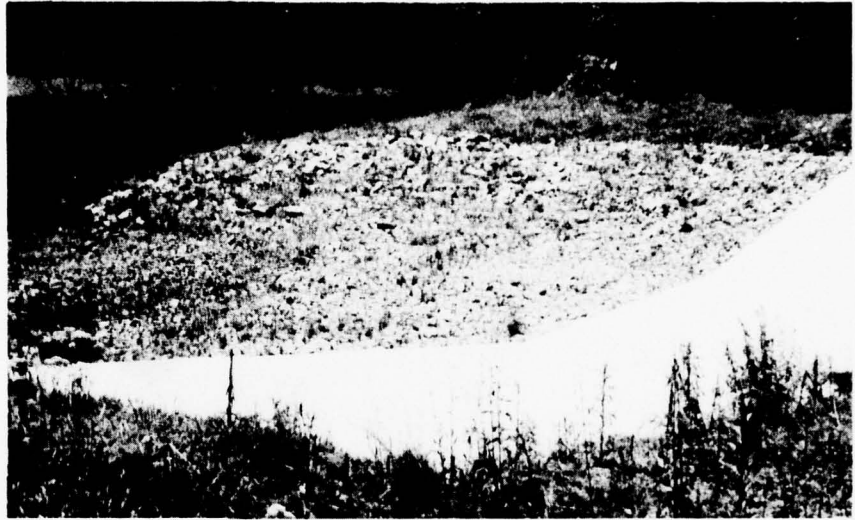
RESERVOIR SIDE OF EMERGENCY SPILLWAY  
NOTE: RIPRAP, ALSO DEAD TREES IN WATER

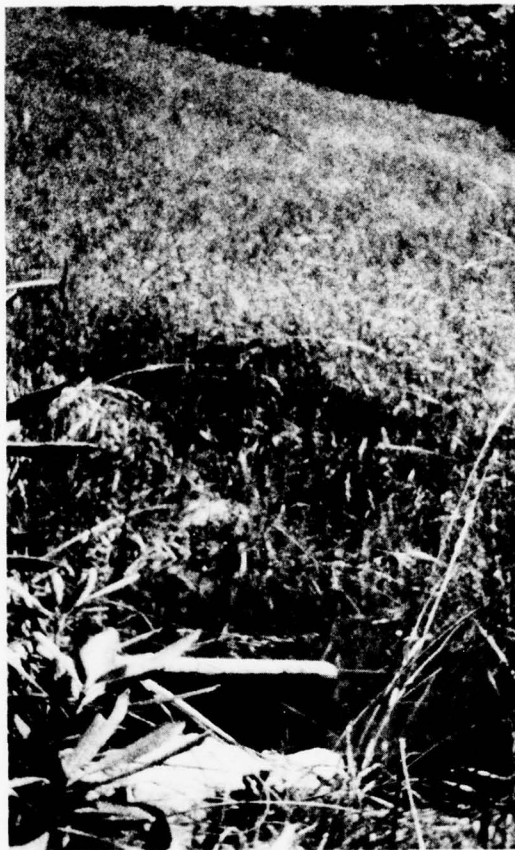
WOODEN MEASURING WEIR
